MODIFICATION ON DLE30

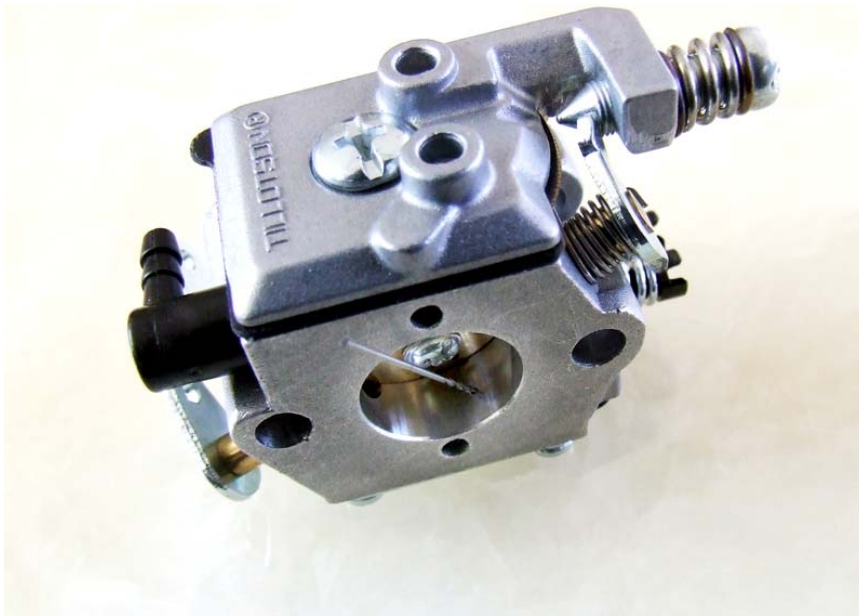
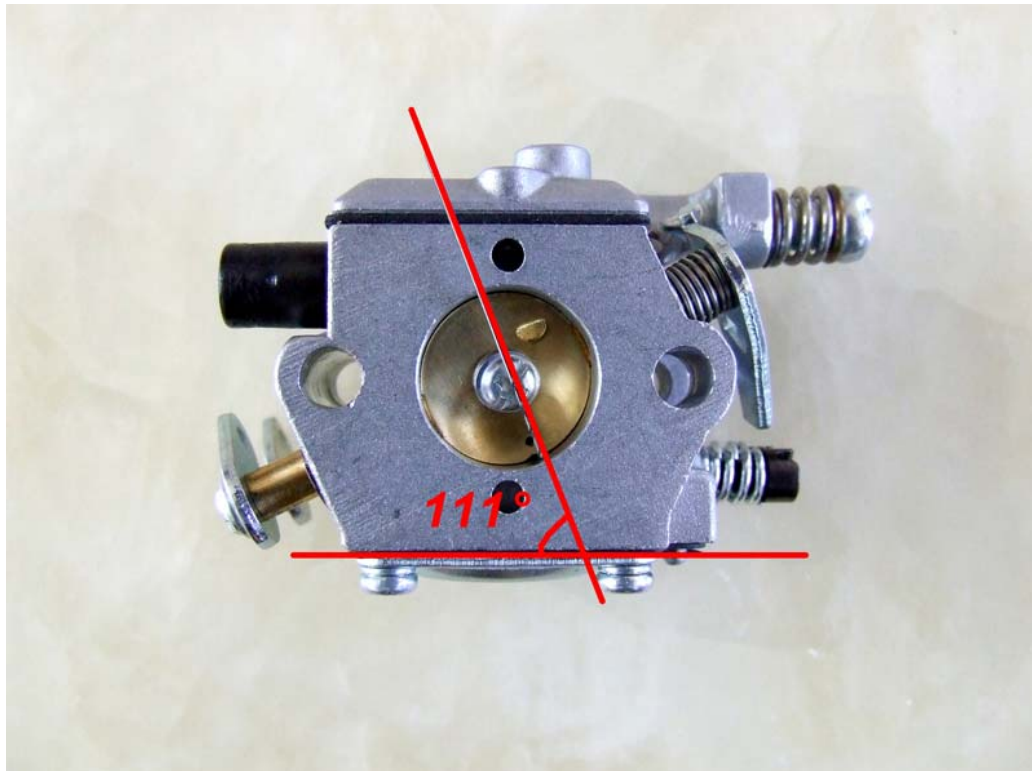
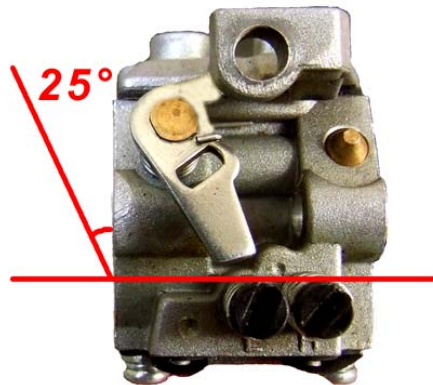
STEP 2

About tilted quit problem, we have been running some many tests and collected reports from many customers, we noticed that tilted quit won't happened in a practical flight. In order to achieve a tilted quit condition, engine must running at idle for a long period around 30sec-1min. However, in a practical flight, the RPM is always changing during the whole flight, performing aerobatics at idle usually results plane stalling and diving. With RPM increasing, engine will be no longer at a tilted quit situation.

Enlarge the idle hole on carburetor with a 0.65mm drilling bit. There is a Small hole in front of throttle plate, use a drilling tool to enlarge it to 0.65mm, please notice the deepness of idle hole is about 1-1.5mm. Be sure you drilling it at a correct angle and deepness or the drilling bit may break inside of idle hole and there is no way to take it out. Please refer pictures below.
